Property Inspection Report

Property Address:

2403 Main St
Bigcity, PA 18040

Date of Inspection: March 20, 2010

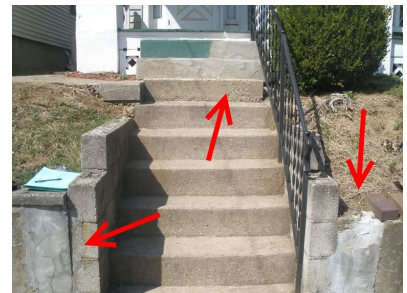
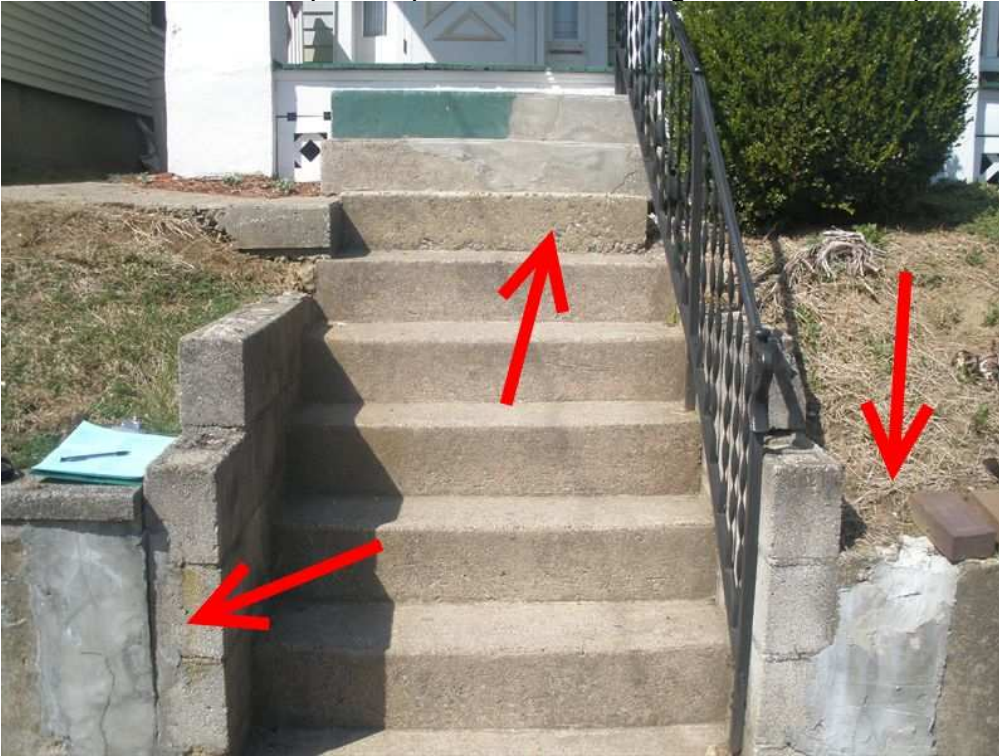
Photo #1 the front steps and part of the retaining wall have been patched

The stairs show signs of decay caused by aging. They have been repaired and are in a safe condition with a firmly attached railing. However, as patches are rarely as stable as the original concrete, the repair patches should be watched for signs of deterioration. (for additional detail see photo 1 on Picture Addendum)

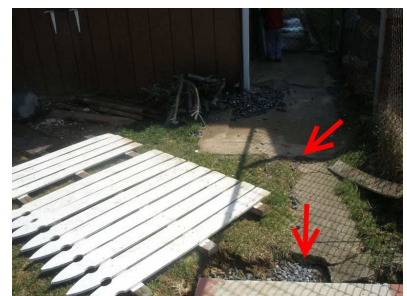
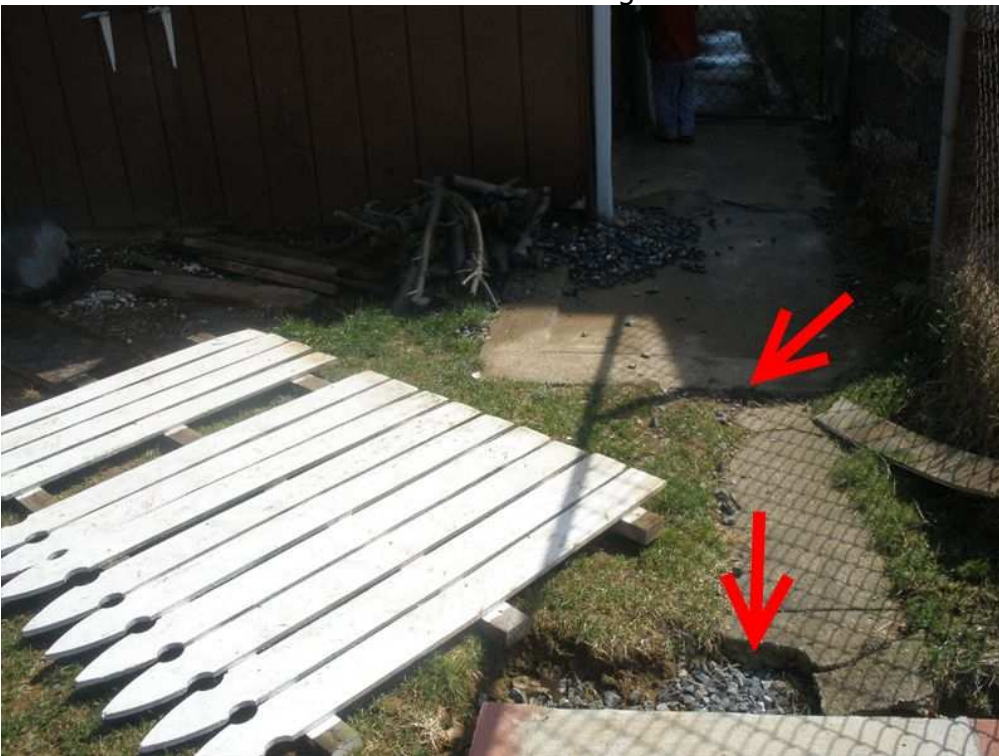
Photo #2 the sidewalk is uneven and cracking

- The sidewalk is spalling.
- There are large cracks in the sidewalk.
- There are uneven spots on the sidewalk.
- The sidewalk has a bad slope.

Major cracks and holes are present in the concrete walkway on the side of and at the back of the house. There is also uneven settling in the concrete. The sidewalk should be repaired because it is a tripping hazard and there is the possibility that uneven settling of the concrete could direct water to the foundation of the home. (for

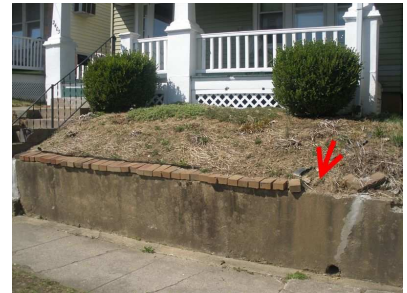
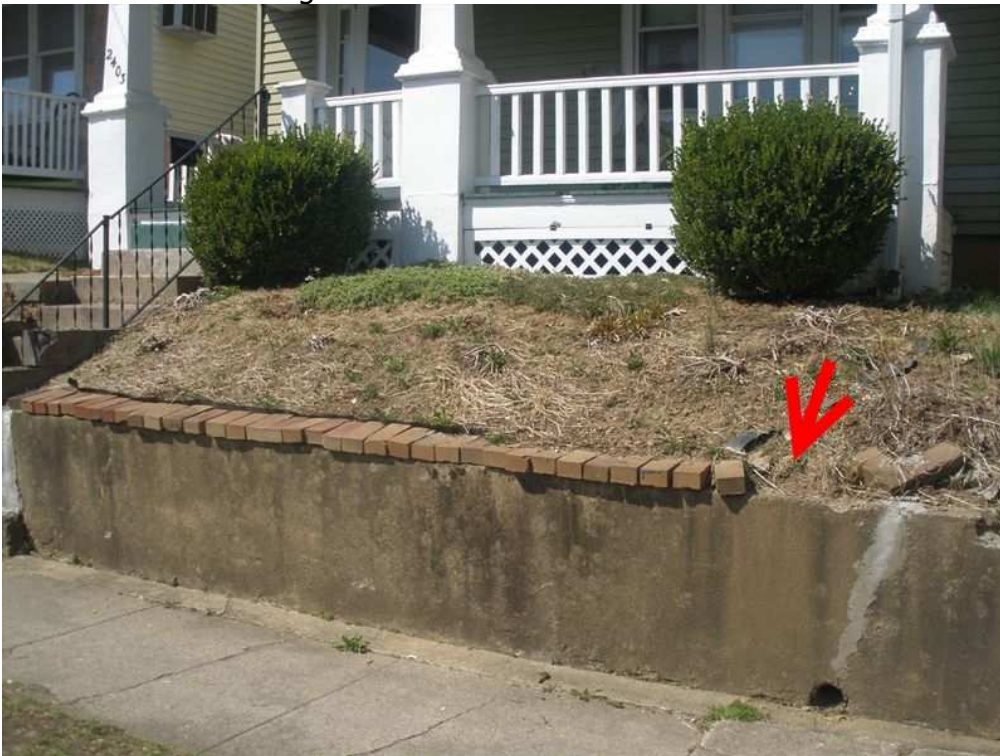
Photo #3 the retaining wall

The retaining wall at the front of the house is leaning towards the sidewalk but currently appears to be stable. There are no weep holes at the base of the wall; this may be a contributing factor in the leaning of the wall. A professional consultation with a qualified landscaper may provide you with more information and a course of action about repairs. Some of the decorative brick caps are missing but this is not affecting the function of the wall. (for additional detail see photo 4 on Picture Addendum)

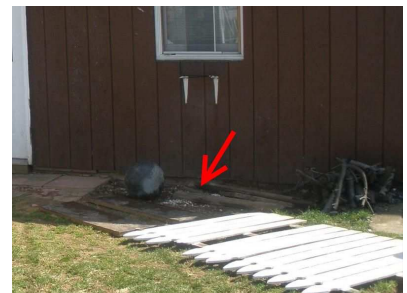
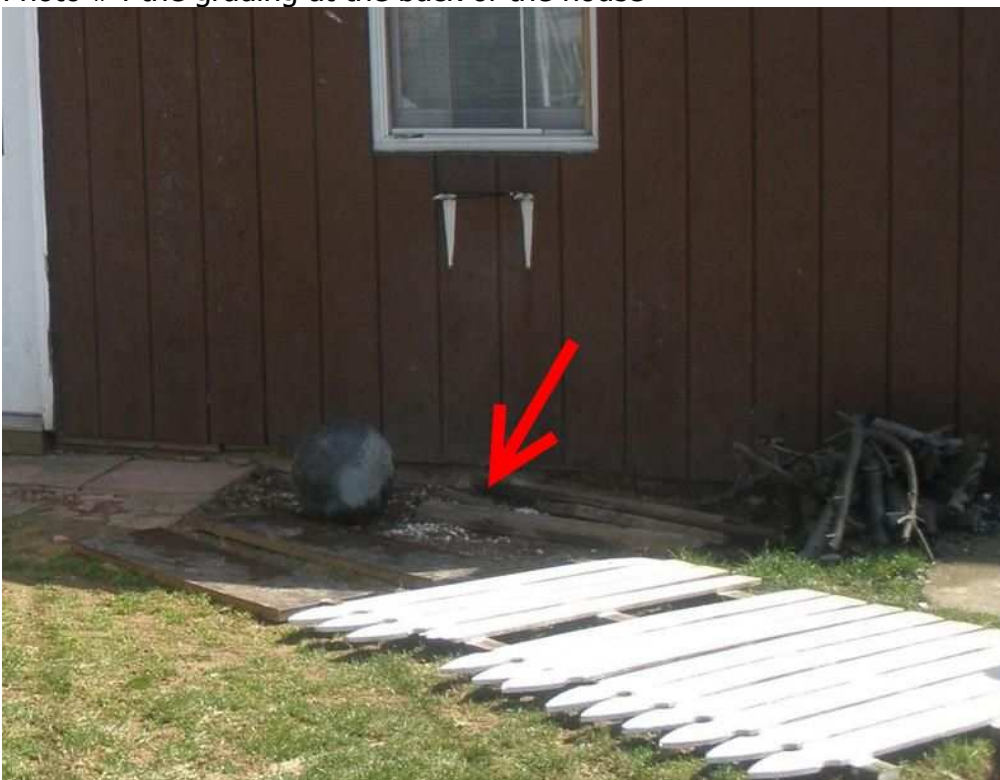
Photo #4 the grading at the back of the house

- The ground slopes toward the house creating a flooding hazard.
- There are low-lying areas where water can pool.

The backyard slopes towards the house and that increases the possibility of water intrusion into the basement. There is a also a low spot at the back of the house that may pool water. Water at the foundation or near the house is always a matter of concern that should be addressed as soon as possible because untended it can lead to a water intrusion at the foundation or into the basement. Additionally, debris should be cleared away from the exterior wall, as this too can contribute to water at foundation or provide an access for pests into the home. (for additional detail see photo 3 on Picture Addendum)

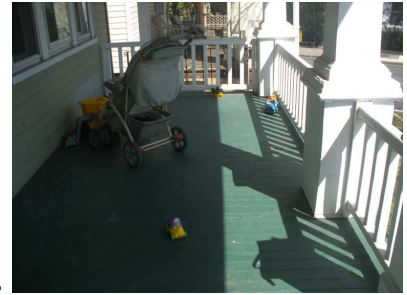
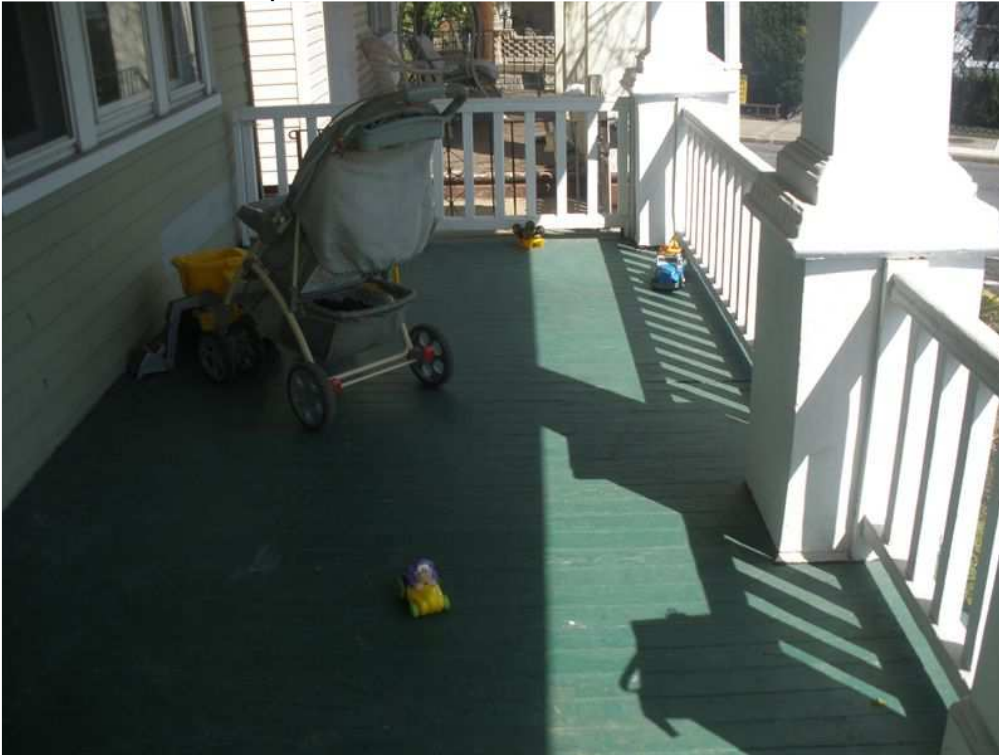
Photo #5 the front porch

The porch is well-secured to the house. It has a strong base and a solid railing. It seems generally well-protected from water damage although there are a few places where the wood is bare of paint. These should be touched up with paint to protect them from water damage. A few of the deck boards were loose and need to be secured. (for additional detail see photo 5 on Picture Addendum)

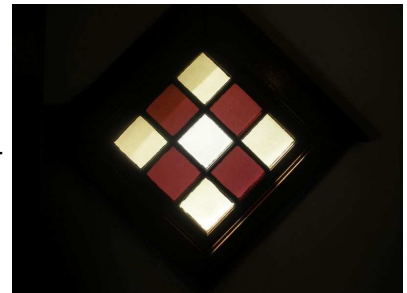
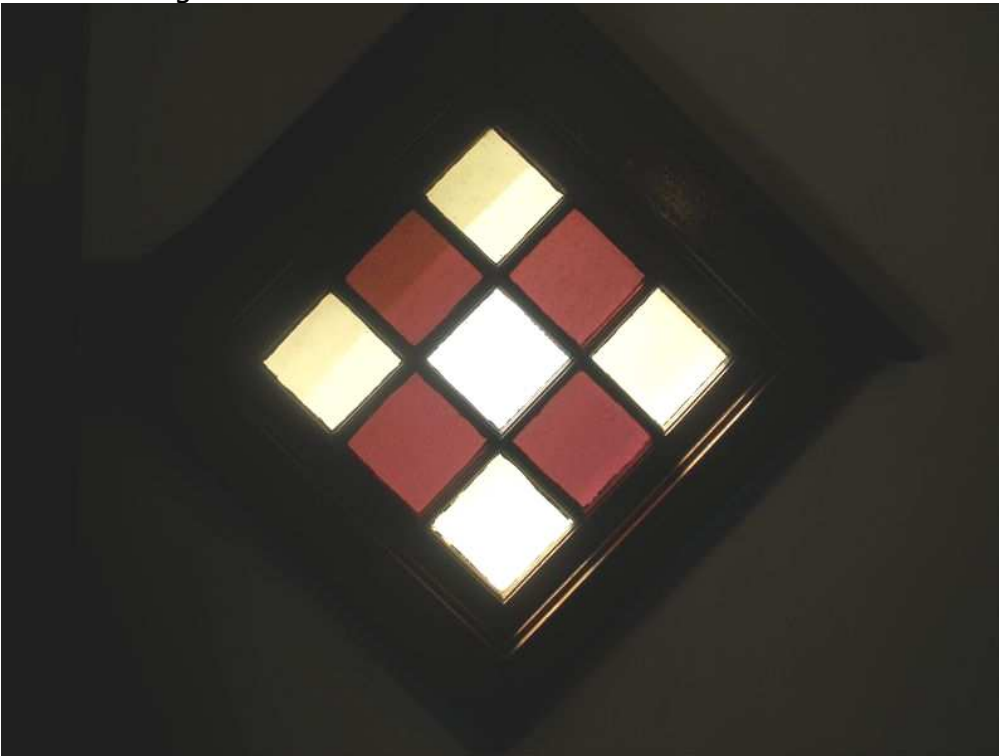
Photo #6 original decorative window

The windows are a mixture of old and new but in satisfactory condition for their age. In some cases, they are original to the house. (for additional detail see photo 6 on Picture Addendum)

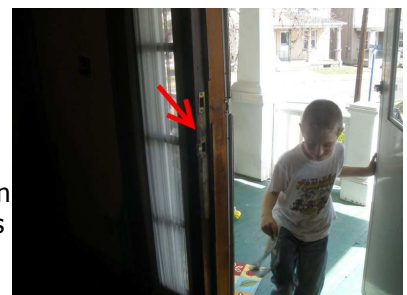
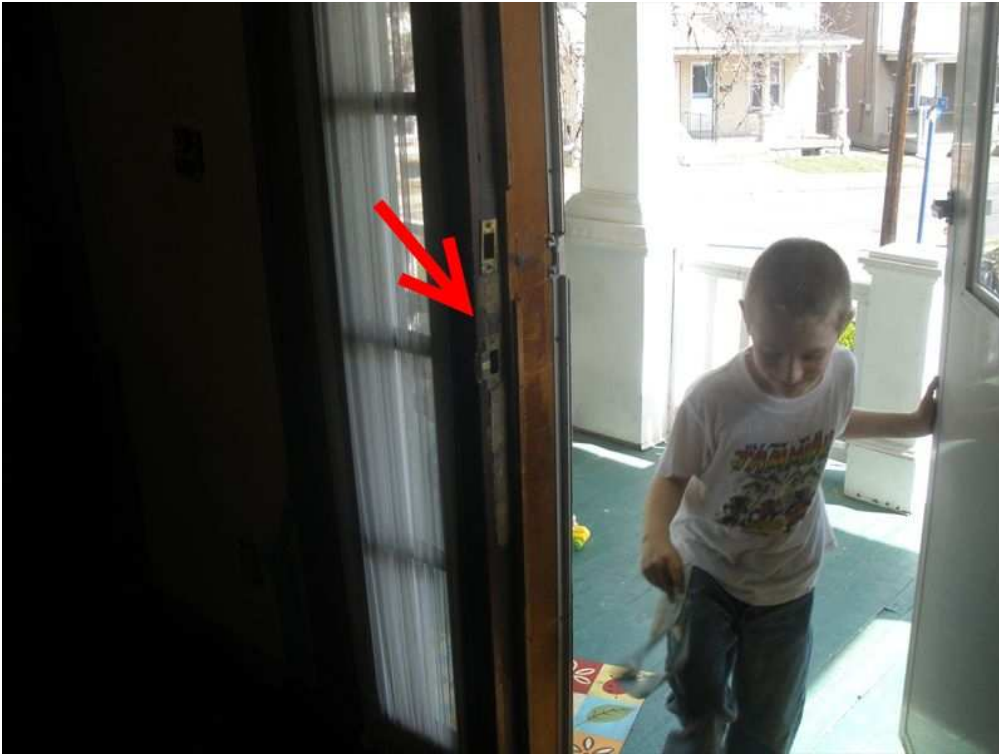
Photo #7 front door

The weather stripping around the front door is damaged and the doorframe is in need of repairs. However, the wood framing is in good condition and there was no sign of rotting on the sill. The rear doorframe is more exposed to the elements and should be kept painted for protection from rain and moisture damage. Otherwise, there is the possibility of wood rot or mold affecting the untreated wood. (for additional detail see photo 7 on Picture Addendum)

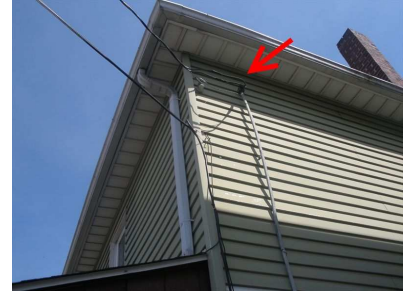
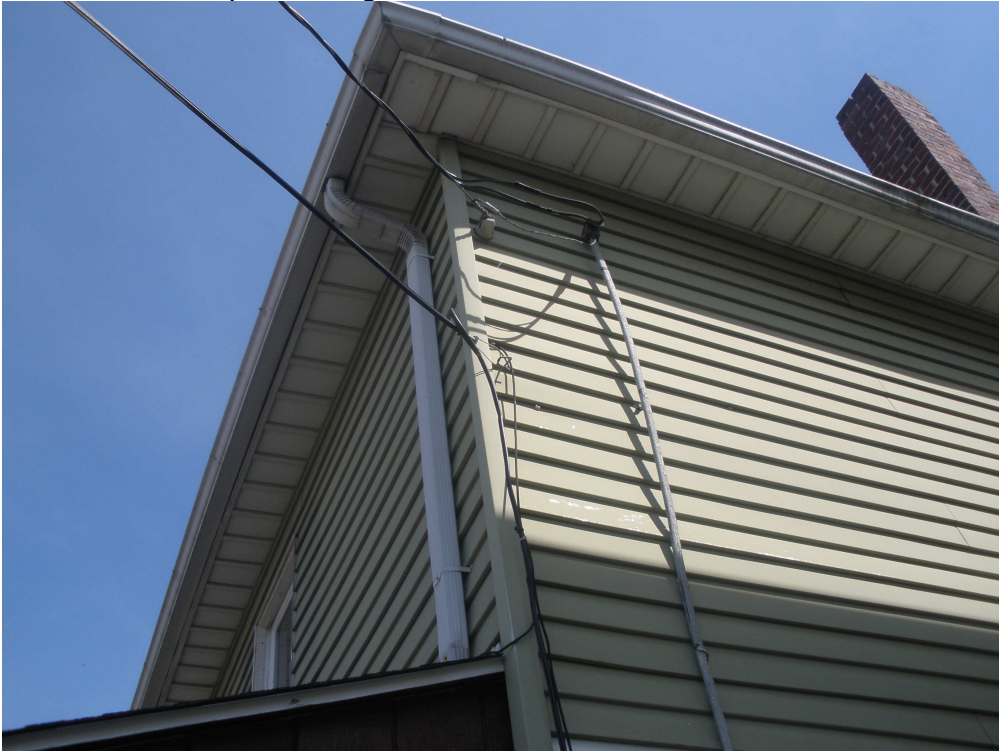
Photo #8 downspout and gutter

The gutter system appears sturdy and firmly attached to the home. Down spouts are adequately supported. (for additional detail see photo 8 on Picture Addendum)

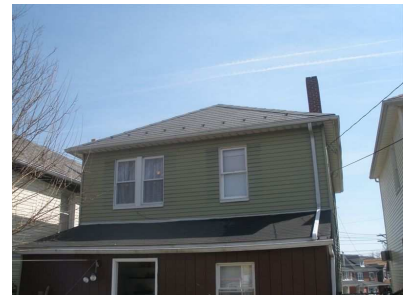
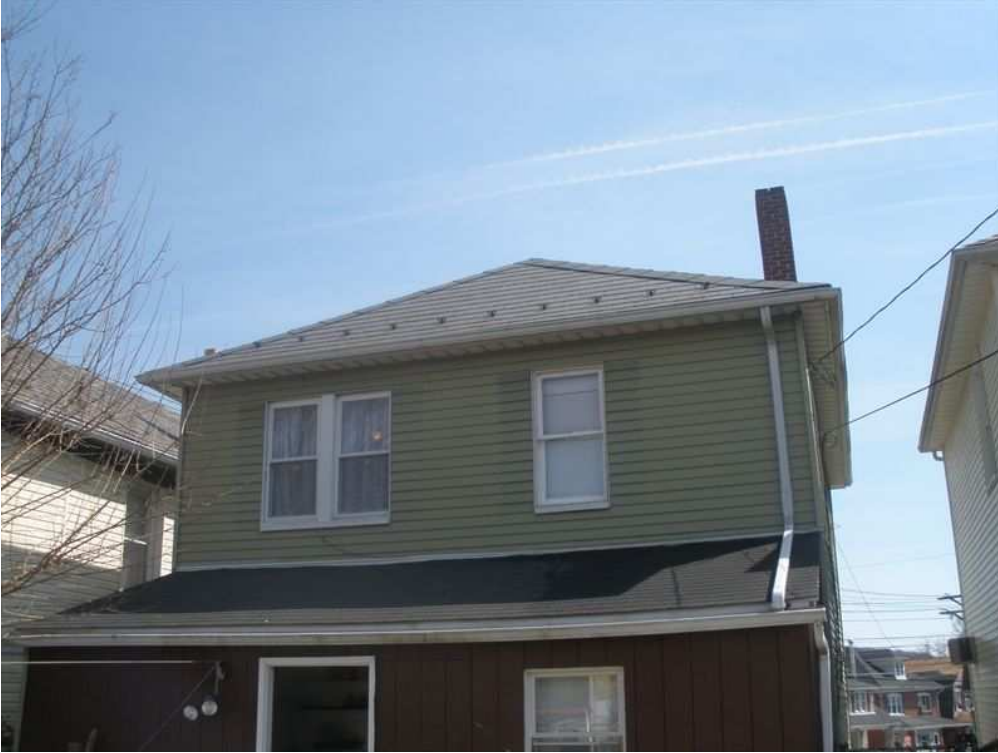
Photo #9 Roof style

The home has two different roof styles. The main portion of the house has a hipped roof. A hipped roof is when all four roof faces rise to a ridge across the top. The smaller portion of the house has a shed roof. A shed roof slopes in one direction only. (for additional detail see photo 9 on Picture Addendum)

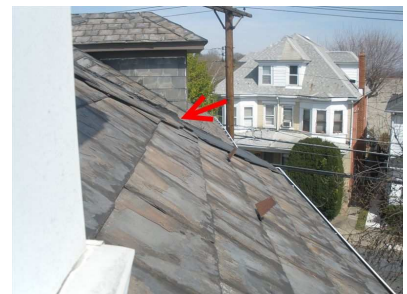
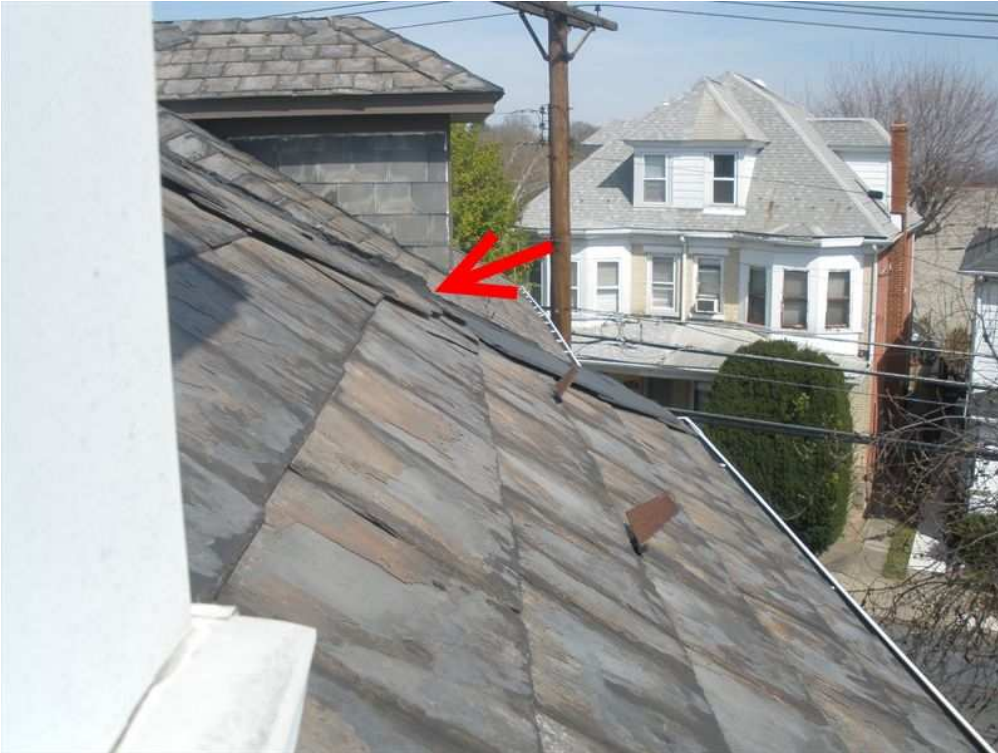
Photo #10 slate roof

The asphalt shingles on the shed roof look to be in good condition and not in need of immediate attention. However, there are damaged and missing tiles from the slate roof on the main section of the roof. A qualified roofing contractor should be consulted about repairs before the roof fails and allows water into the attic. (for additional detail see photo 10 on Picture Addendum)

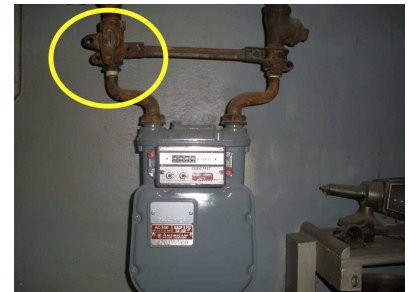
Photo #11 natural gas meter

The gas shut off appears to be rusted. This could be a safety hazard and a qualified professional should be consulted. (for additional detail see photo 11 on Picture Addendum)

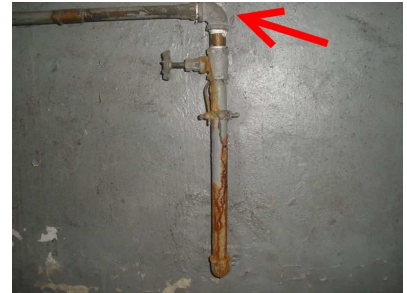
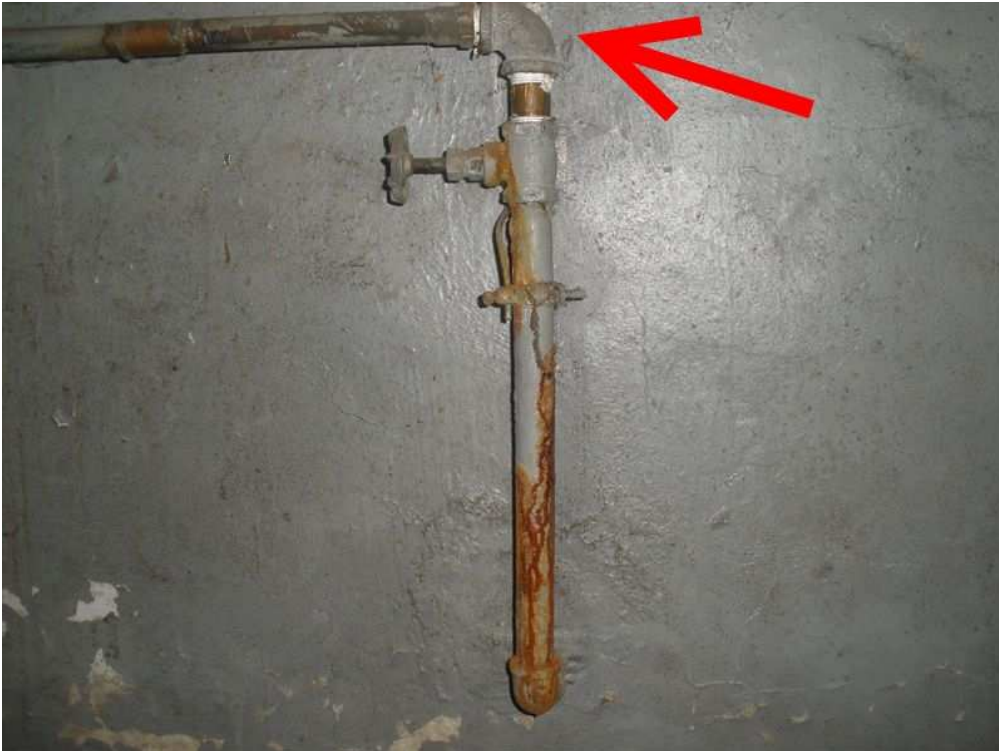
Photo #12 water line

- There is rust or corrosion at the water entrance.
- There is seepage around the stem.

The water entrance pipe shows visible signs of external corrosion and it is leaking water into the basement. Copper and galvanized pipes should never connect to each other, this results in a type of corrosion called electrolysis. The pipes should be disconnected then rejoined by a dielectric union and then water testing is recommended to determine if rust is entering the home's drinking water. (for additional detail see photo 12 on Picture Addendum)

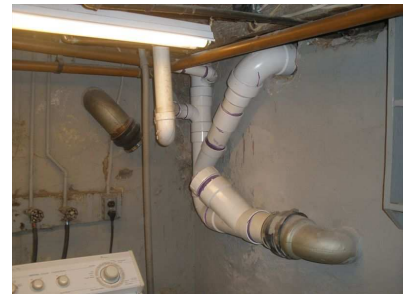
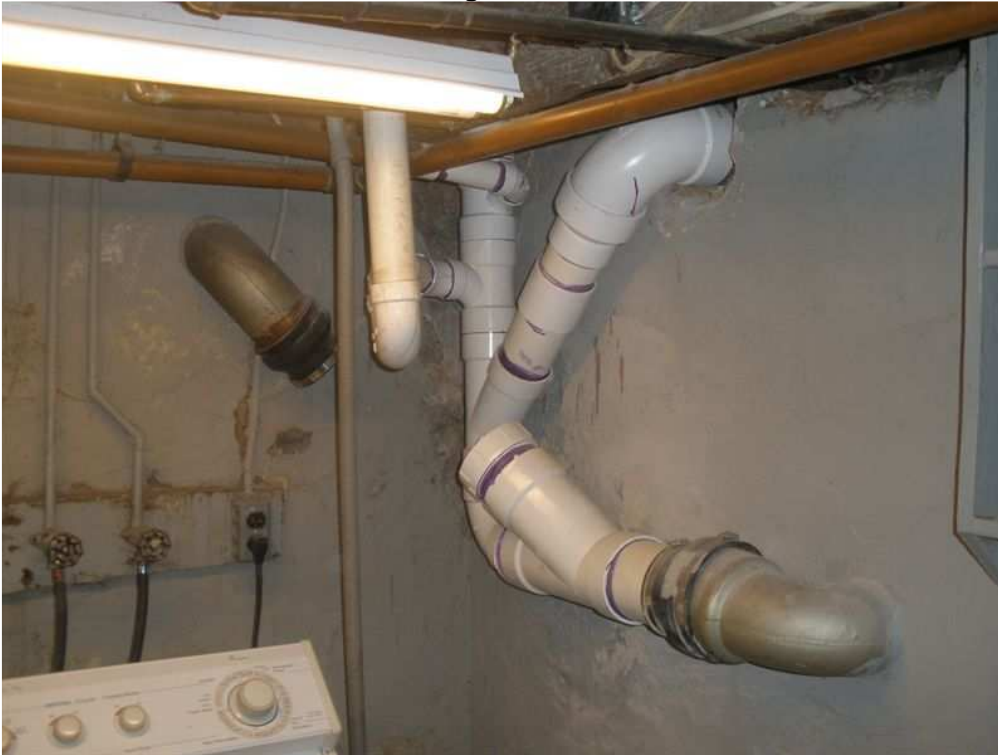
Photo #13 waste water and sewage

The waste / sewage pipes are new and show no sign of leakage. (for additional detail see photo 13 on Picture Addendum)

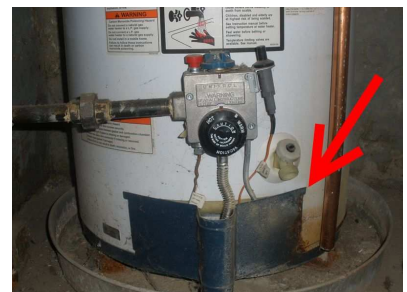
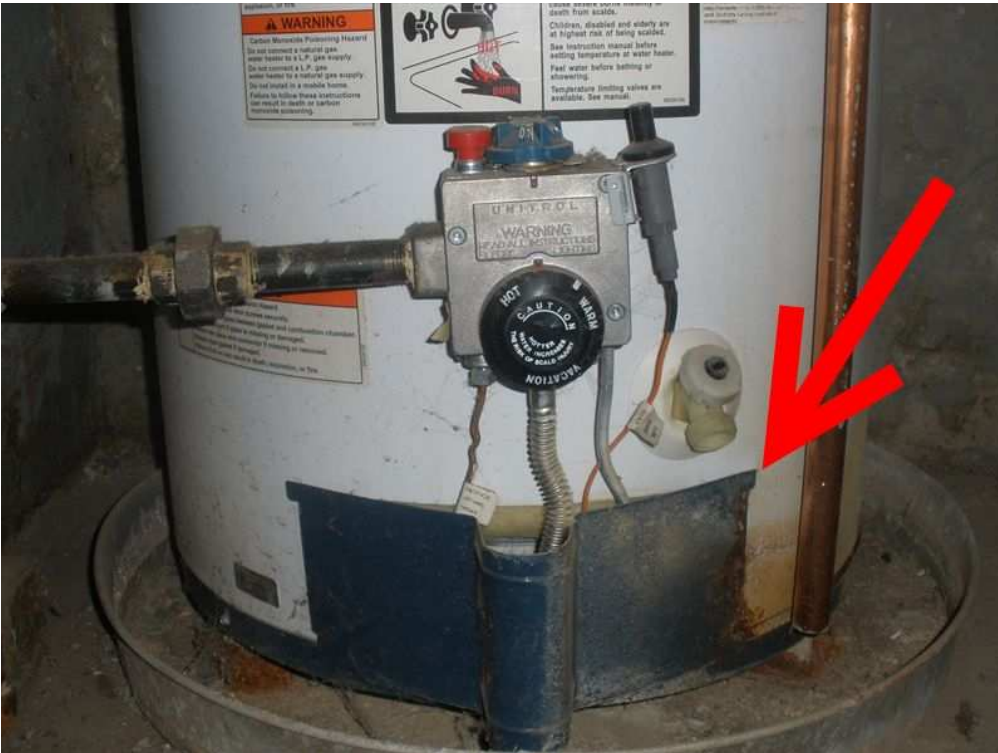
- There are signs of leakages.

There is evidence of corrosion and some leaking on the outside of the water heater. This water heater is 6 years old, the typical gas water heater life is 8 - 12 years. Cleaning and proper maintenance by a qualified professional is recommended to keep the unit in good working order. (for additional detail see photo 14 on Picture Addendum)

Photo # 14 water heater corrosion

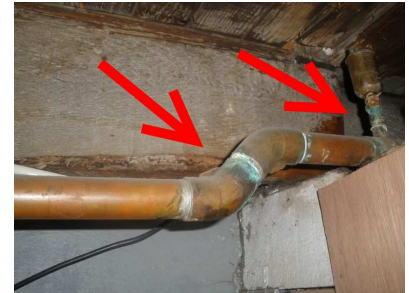
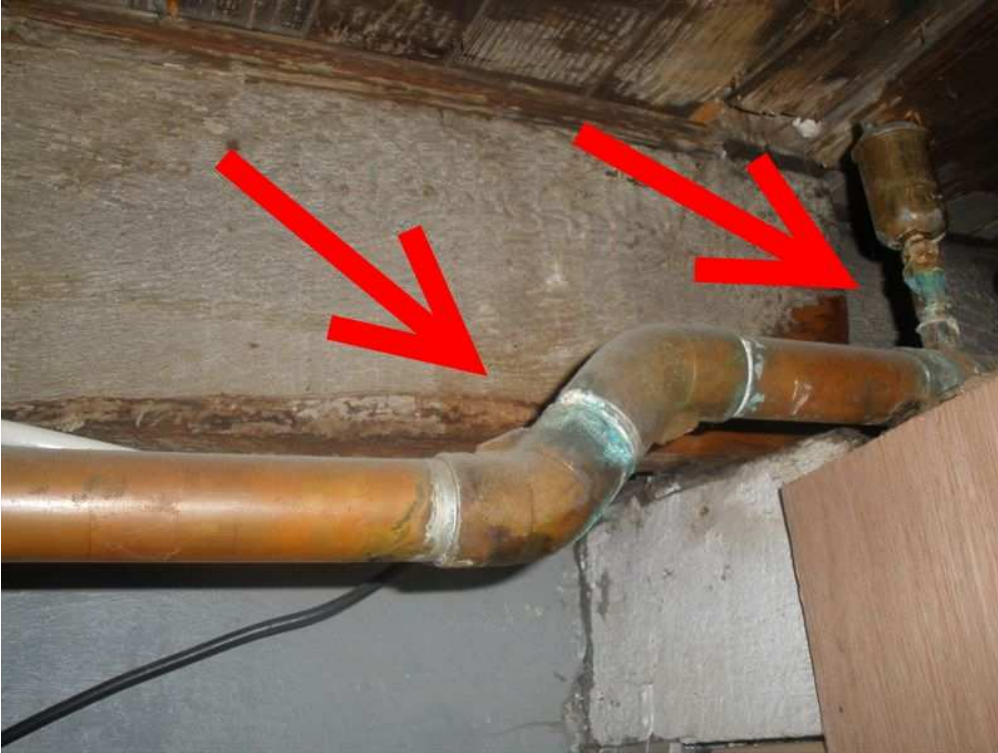
Photo #15 copper pipes

- There are signs of seepage from the pipes.
- There are signs of rust/corrosion on the pipes.

There is some external corrosion of the water pipes but this is not exceptional given the age of the system. A qualified plumber could advise about needed repairs. (for additional detail see photo 15 on Picture Addendum)

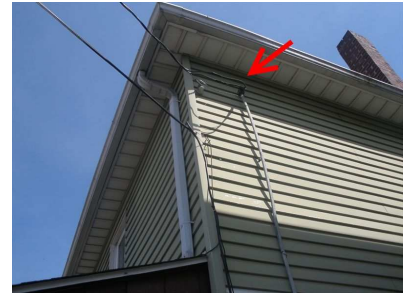
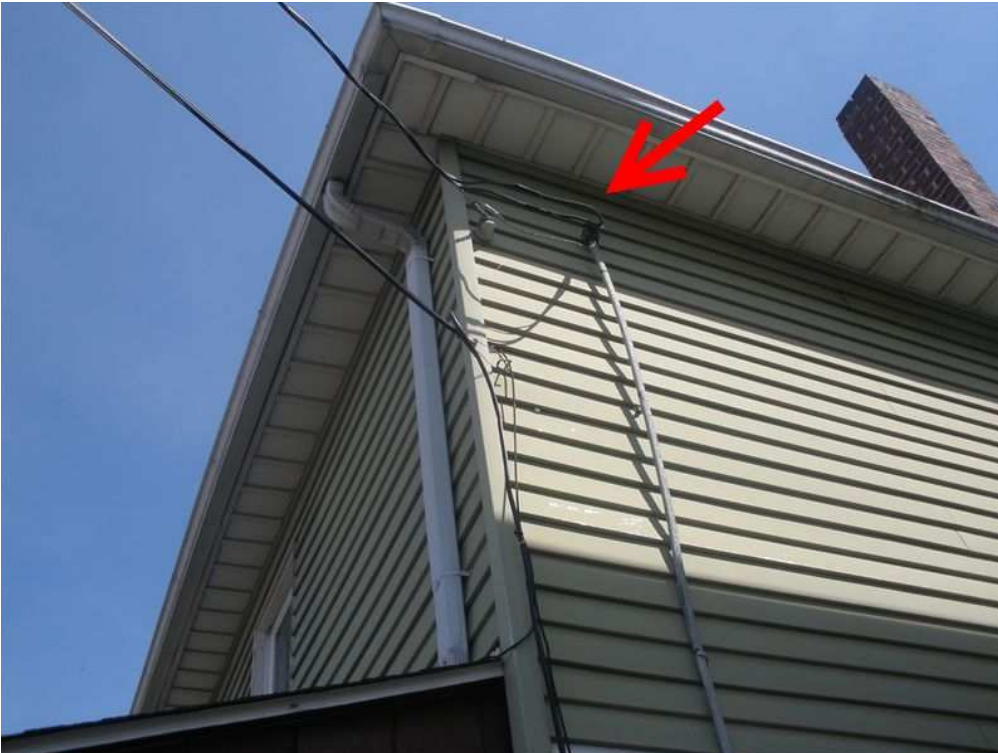
Photo #16 electric service line

The service entrance wiring is in good condition, the wiring is not frayed or touching the house. There are no trees or obstructions interfering with the lines. (for additional detail see photo 16 on Picture Addendum)

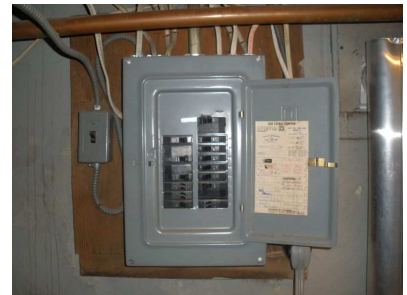
Photo # 17 main service panel

The box is properly labeled and none of the circuits are double tapped. There is no evidence of rust or corrosion affecting the wiring. (for additional detail see photo 17 on Picture Addendum)

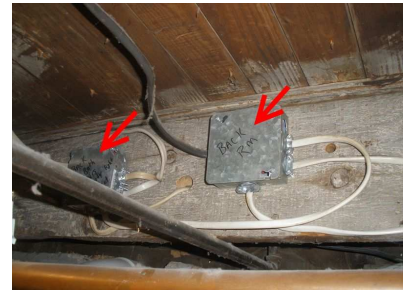
Photo #18 marked junction boxes

The electrical wiring is properly protected and all wire splices are within junction boxes. (for additional detail see photo 18 on Picture Addendum)

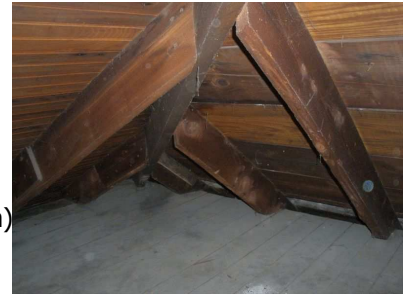
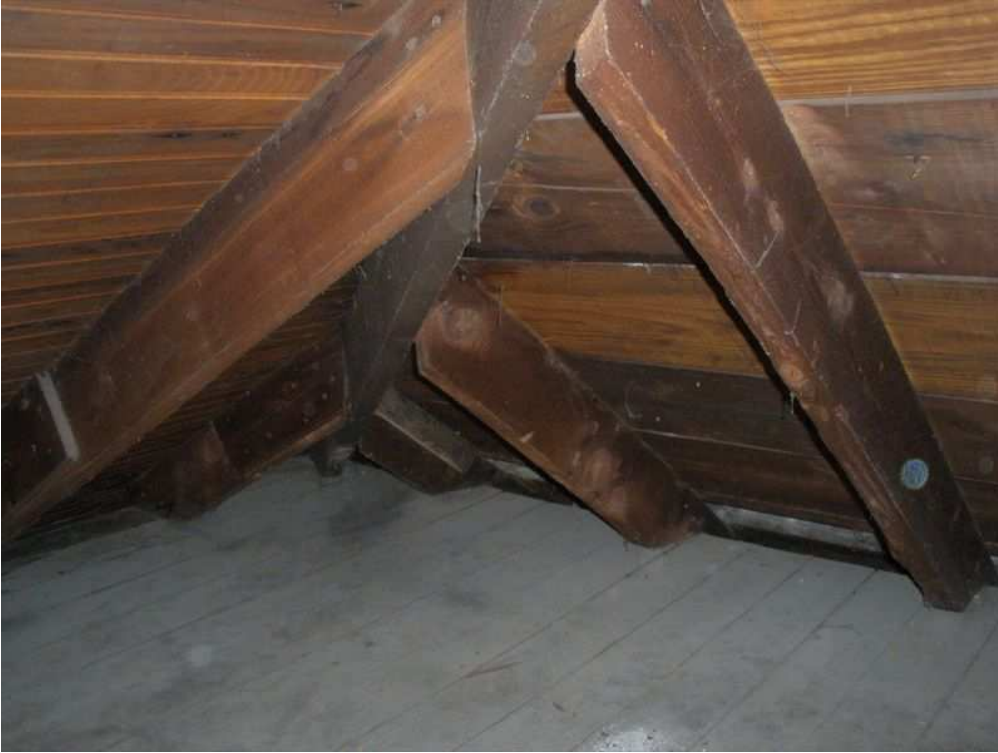
Photo #19 roof frame

There was no sign of deterioration of the roof frame and no broken or missing sections of the rafters. (for additional detail see photo 19 on Picture Addendum)

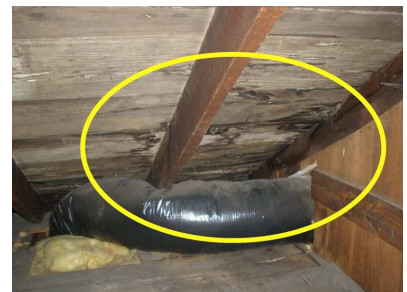
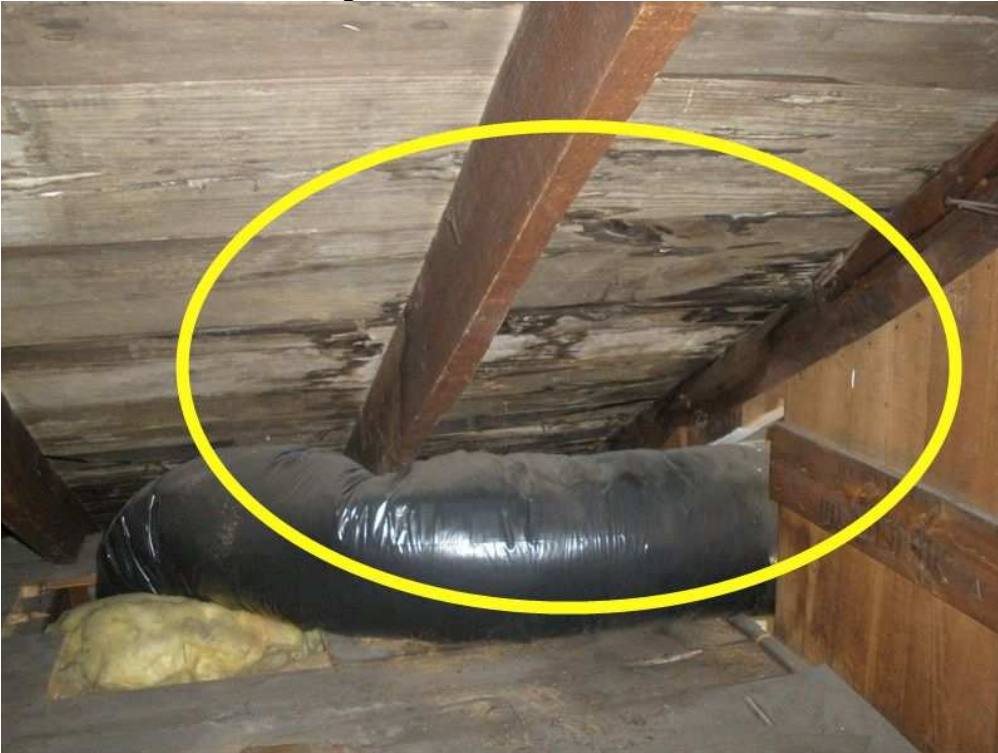
Photo #20 attic sheathing

- There are signs of leakages on the sheathing.
- There are signs of water damage to the sheathing.

There are signs of water damage to the sheathing which could indicate that the roof has problems with leakage in the past. It is recommended that the roof be examined by a qualified roofing contractor. (for additional detail see photo 20 on Picture Addendum)

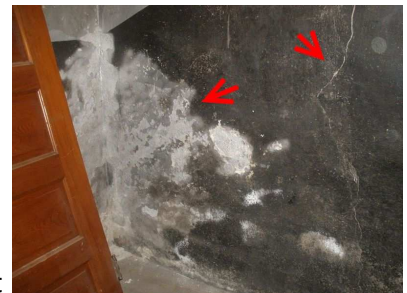
The front wall foundation shows signs of cracking and water damage. The paint peels and chips along the front wall and the right wall (facing the house from the street) - there is evidence of moisture accumulating in the basement and coming through the walls. A qualified contractor or structural engineer can examine the damage and make suggestions about repairs. (for additional detail see photo 21 on Picture Addendum)

Photo #21 foundation water damage

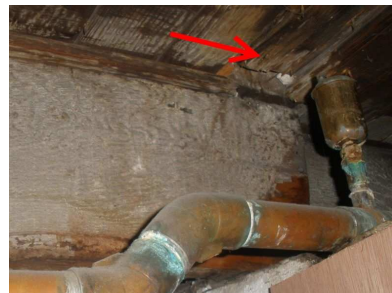
Moisture stains were observed on the sub floor beneath the kitchen sink. This was probably caused by an old leak as there was no damage visible from beneath the sink. (for additional detail see photo 22 on Picture Addendum)

Photo #22 sub flooring water damage

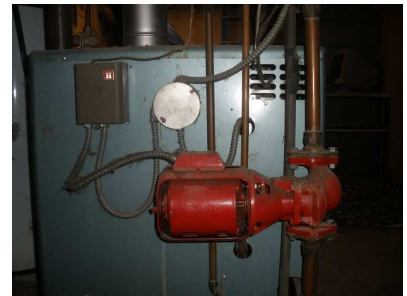
The home's thermostat was contributing to difficulty determining whether the heating system is fully operational. The 25 year old White Rodgers model is one of the earliest programmable thermostats and, unfortunately, the operating instructions were lost and no longer available. However, I have provided the operating instructions for a similar model as recommended by the original manufacturer. With that we were able to determine the system was functioning. (for additional detail see photo 23 on Picture Addendum)
